USAAMRDL-TR-76-6

DEVELOPMENT OF DESIGN AND MANUFACTURING TECHNOLOGY FOR BALLISTIC-DAMAGE-TOLERANT FLIGHT CONTROL COMPONENTS

Bell Helicopter Company P. O. Box 482
Fort Worth, Tex. 76101

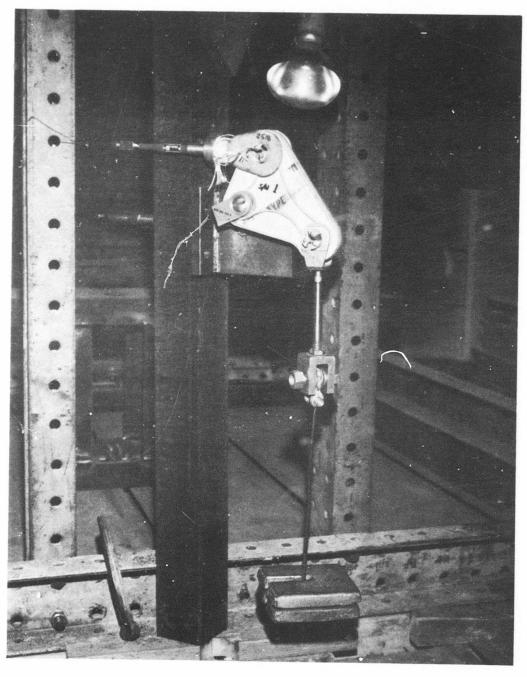
Figure 21 shows the damage sustained by specimen No. 1, while Figures 22 and 23 show the damage to specimen No. 2 during the ballistic test. Both specimens moved freely at the damaged junction and did not exhibit any significant amount of slack either laterally or radially.

Figure 21. Ballistic test fixture and specimen no. 1 after impact.

Specimen no. 1 failed under a maximum tensile load of 1841 pounds. Failure occurred from lateral buckling of the bell-crank and subsequent cracking around the pivot bearing.

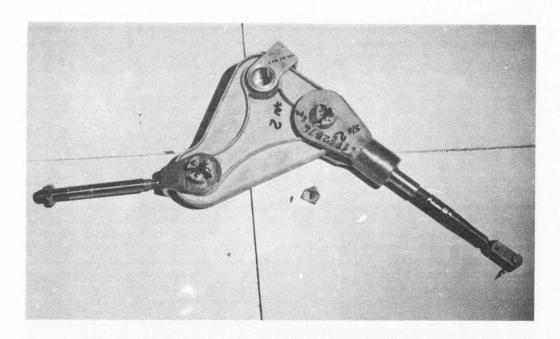
Figure 22. Results of ballistic test on specimen no. 2 - entry side.

On specimen no. 2, the side of the clevis that had been partially severed during the ballistic test failed at 312 pounds applied tensile load. The other side of the clevis fractured at 525 pounds applied tensile load, resulting in a complete loss of load-carrying capability. Limit load is 424 pounds.

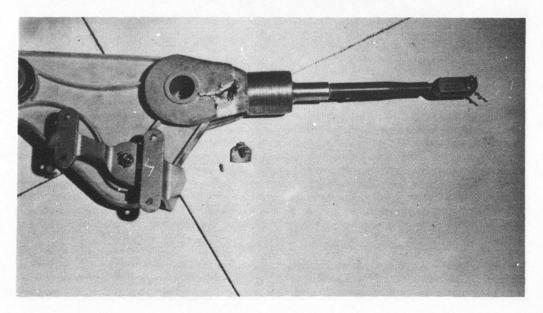
Figure 23. Results of ballistic test on specimen no. 2 - exit side.
